# Barwon Coast Creating Connection Places & Spaces Access Audit

## Access Audit Action Report Stage 3

30/07/2025

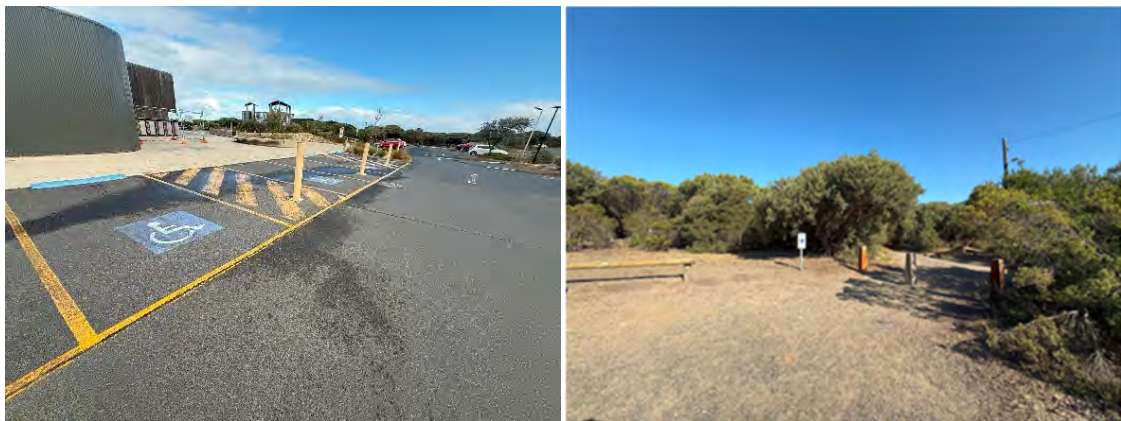
The level of compliance with accessible car parking provisions varies significantly across Barwon Coast sites. While Ocean Grove Main Beach demonstrates near complete alignment with current Australian Standards, which is well connected and prominent, many other locations fall considerably short of the required benchmarks, in some instances a simple sign is provided.

Figure 7: (a) Accessible Parking at Ocean Grove main beach (b) Accessible parking at Collendina beach

Barwon Coast can prioritise upgrading existing accessible parking and establishing new bays in alignment with the individual location section of this report's recommendations and the master plan currently in development. It is advisable to target high use areas first, such as Ocean Grove Main Beach, followed by locations that require substantial infrastructure improvements to ensure a cohesive user experience.

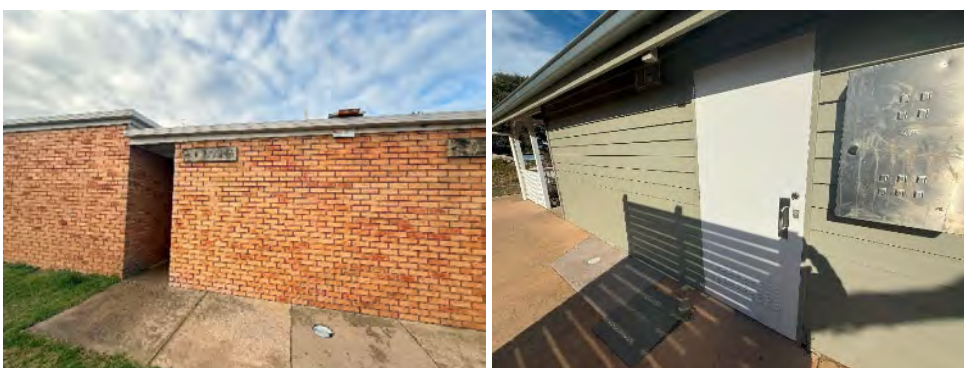
These signage categories are highly visible and consistent across the region. However, signage related to accessibility, inclusive amenities, and wayfinding is noticeably limited or inconsistent.

Figure 9: (a) Incorrect accessible signage (b) no signage on bathroom door

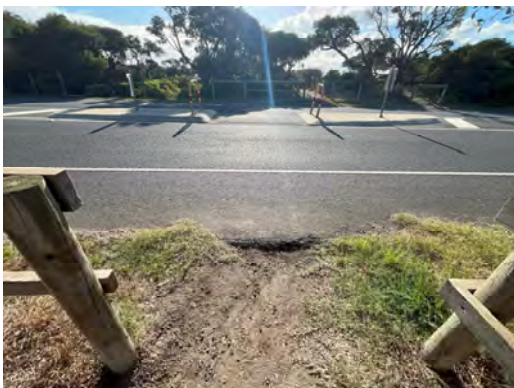
Figure 12: (a) No warning kerb to roadway

It is acknowledged that Barwon Coast is required to consult with COGG and Department of Transport and Planning (DPT) on infrastructure changes aligned with roadways and public transport, that included the provision of kerb ramps and Tactile Ground Surface Indicators (TGSIs) which are discussed later in the report. It is recommended that Barwon Coast seek clarification on the “standard” that these two authorities have on the provision of kerb ramps, and advocates for their installation with specific reference to:

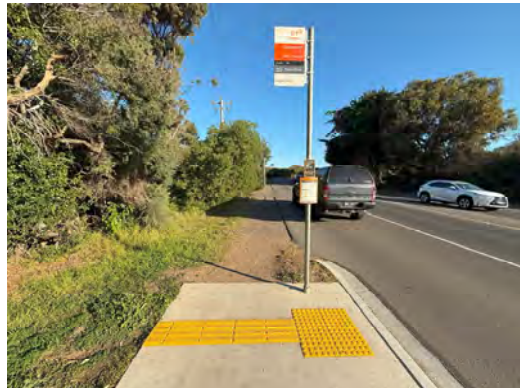
b) No kerb to bus stop

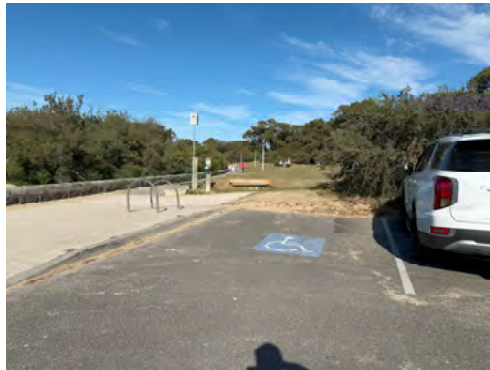
(c) No kerb ramp at accessible parking bay

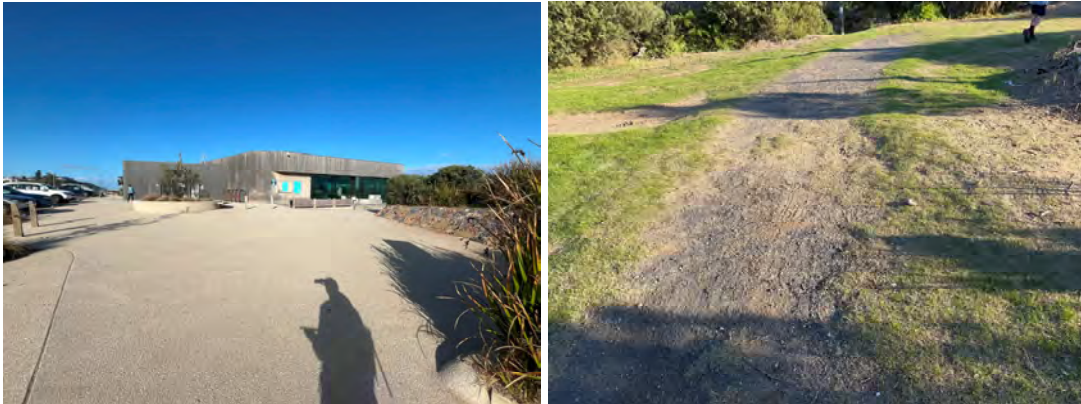
Conversely, in more natural or lower maintenance areas, the CAPT is often composed of unsealed, uneven, or eroded surfaces that do not meet accessibility requirements. These informal paths frequently lack the minimum clear width, contain loose or unstable material (e.g. gravel, mulch, or exposed root systems), and present level changes or crossfalls that hinder safe passage.

Figure 13: (a) Sealed pathway at Ocean Grove main beach (b) Non maintained path along river

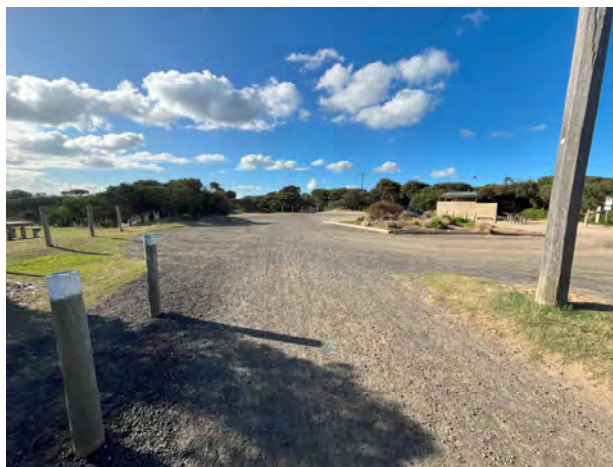
**Figure 15: Lack of contrast and definition of pathway as interacts with vehicle, Raff's Beach**

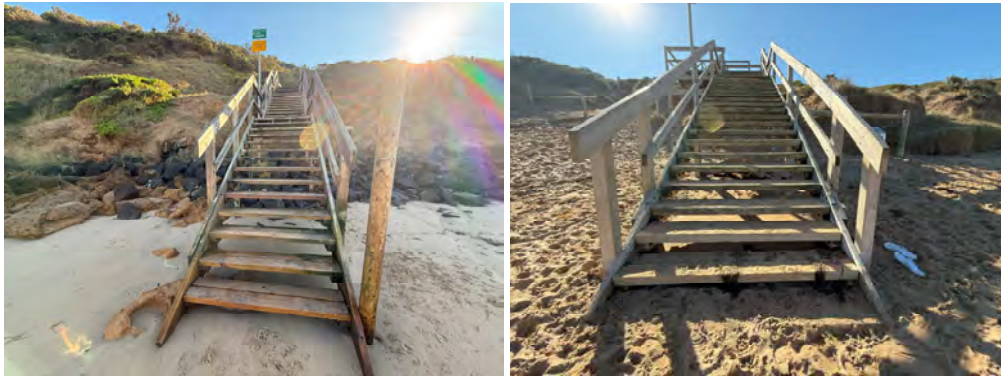
- Open risers, which reduce visibility and stability
- Non-compliant handrails, often missing required extensions or correct diameter
- Absence of tactile ground surface indicators (TGSIs) at top and bottom landings
- Lack of contrasting stair nosings, limiting visual cues for step edges

Figure 17: (a) Timber stairs at Hodgson and (b) Collendina beach

Where timber stairs are currently in use, alternative materials such as fibre-reinforced plastic (FRP) treads should be considered as a potential replacement, subject to designer and engineering assessment. FRP treads offer several benefits:

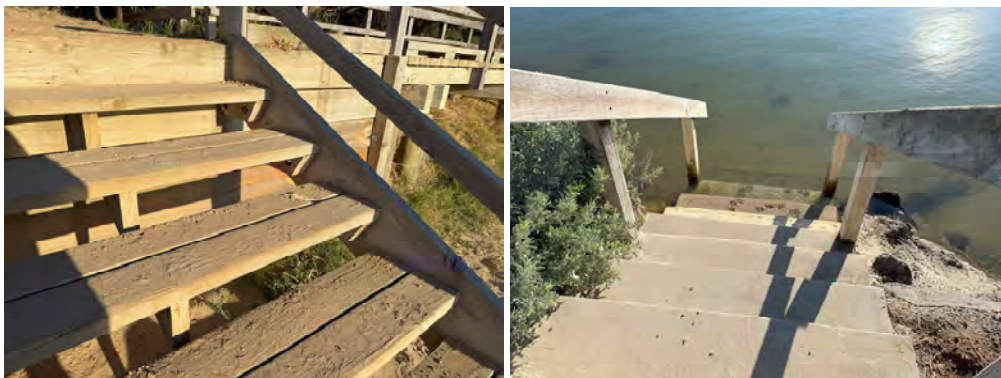
Figure 18: (a) Stairs at Ocean Grove boardwalk near bridge (b) Stairs to access river Ocean Grove side

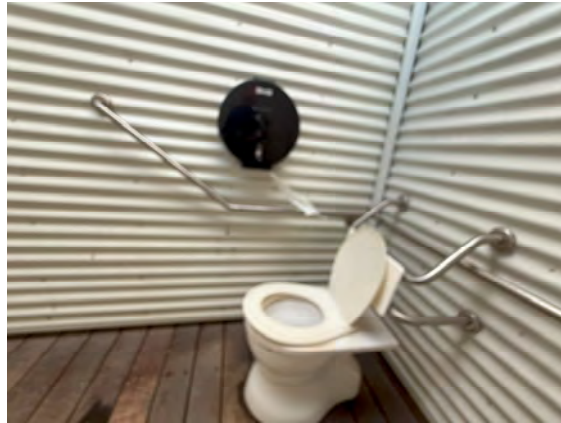
**Currently,** the toilet block at Ocean Grove Main Beach includes many of the necessary accessible features, though not all. At other locations, including the unsealed carpark on the Ocean Grove side of the Barwon River bridge, Frank Ellis Reserve in Barwon Heads, and Bancoora Surf Life Saving Club, toilet facilities are signed as accessible but do not meet the minimum requirements under AS 1428.1:2021.

Figure 20: "Accessible" toilet at (a) Ocean Grove unsealed carpark bridge

As outlined in the site-specific assessments, several facilities across the coast warrant repair, upgrade, or reconstruction to align with the accessibility requirements detailed in AS 1428.1:2021. Barwon Coast should consider adopting a systematic approach to upgrading its full suite of toilet amenities. Priority attention should be given to high use areas, including:

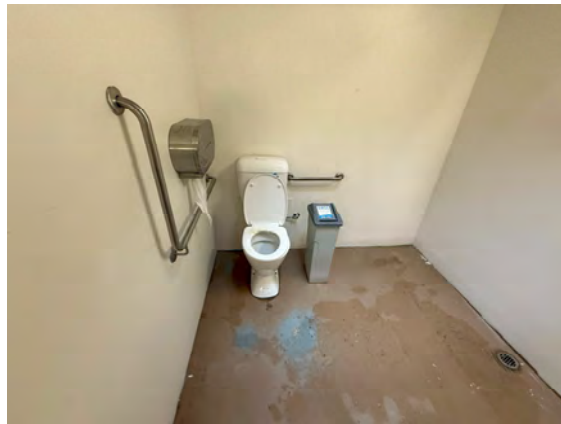
(b) Frank Ellis Reserve toilet bank

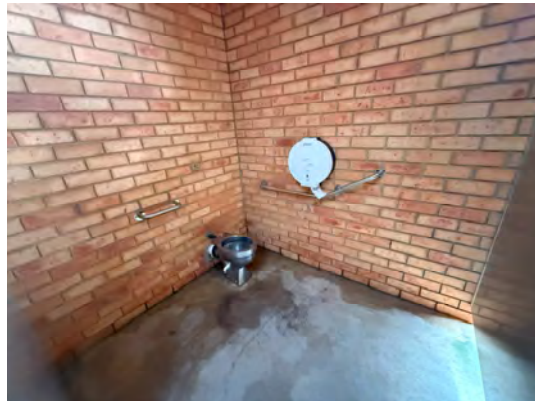
(c) Bancoora Beach

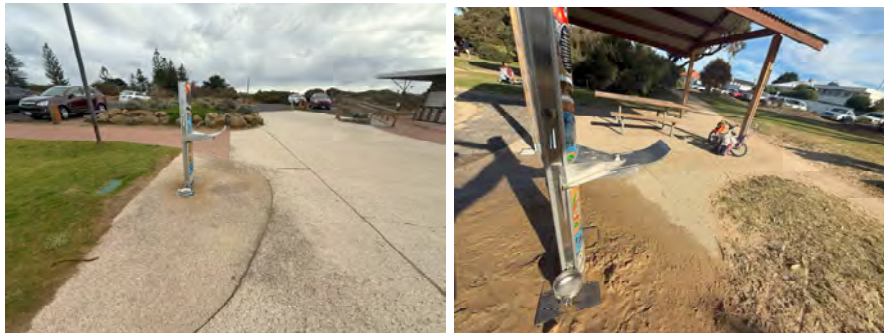
Barwon Coast have commenced the installation of several drinking fountains over recent times. This has been a positive addition and has integrated culture important artwork to further increase the inclusivity of the region. The location of fountains is often aligned to CAPT and other infrastructure, in high use areas. Some challenges are seen in access to the fountains due to location, circulation space and ground surfaces.

Figure 29: (a) Drinking fountain Ocean Grove Main Beach (b) Frank Ellis Reserve playground

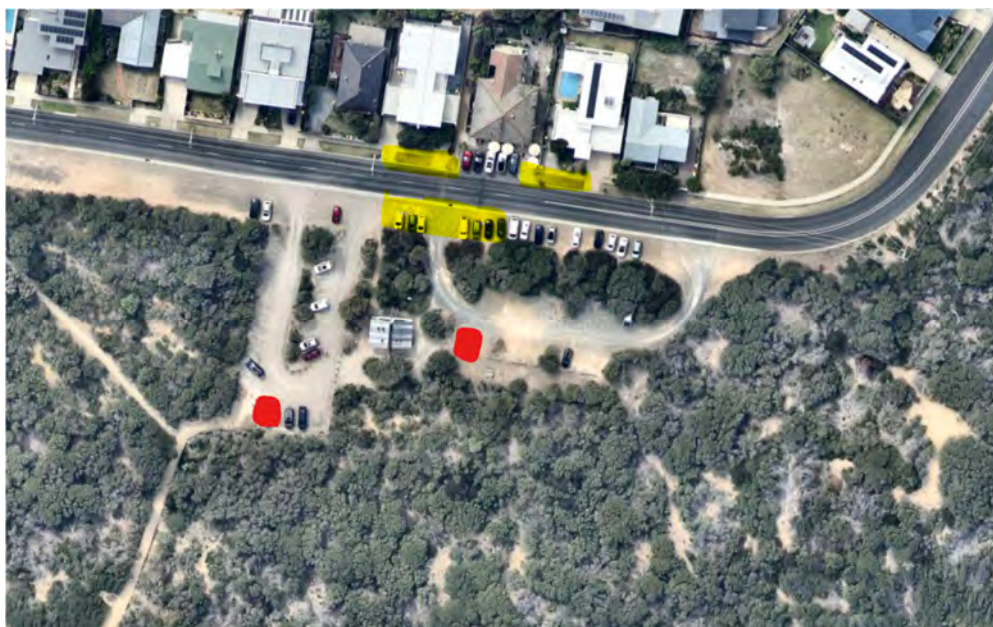
**Finding:** A single accessible parking bay exists but fails compliance, missing surface markings, shared zone, and compliant pathway connection.

Figure 32: Potential new accessible car parking bay locations (red) and bus drop off locations (yellow)

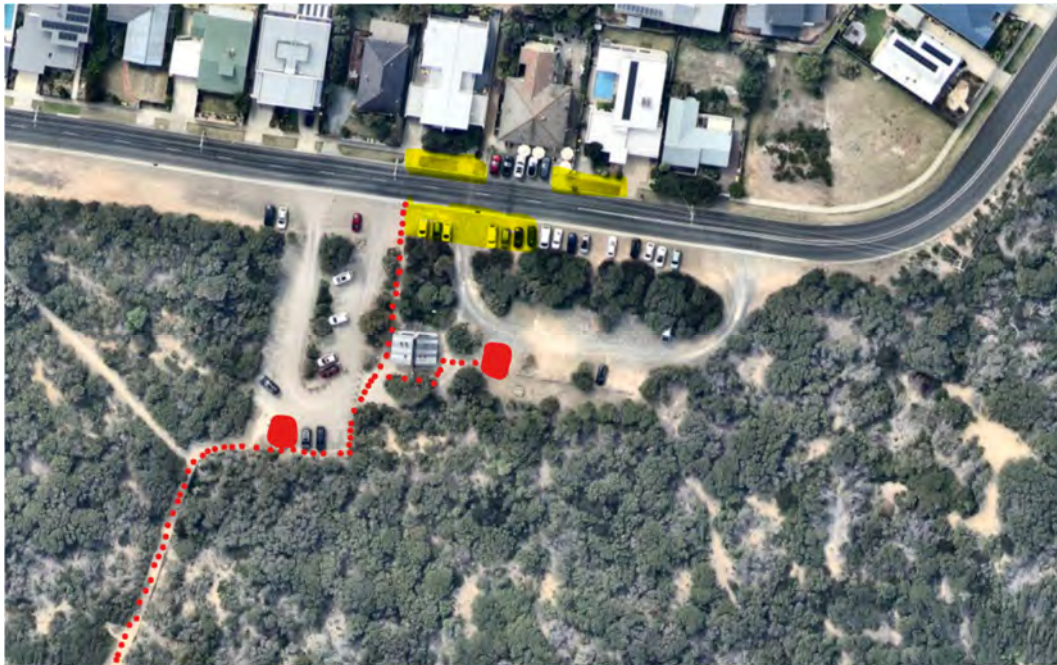
**Finding:** Pathways are disconnected, non-compliant, and uneven. The surface quality varies with vegetation overgrowth, deep ruts, and lack of pedestrian priority through car parks. It is noted of a preexisting pathway that is now blocked off that navigates its way down the dune directly next to the stairs.

Figure 33: Potential CAPT
