# Barwon Coast Creating Connection Places & Spaces Access Audit

## Access Audit Action Report Stage 3

30/07/2025

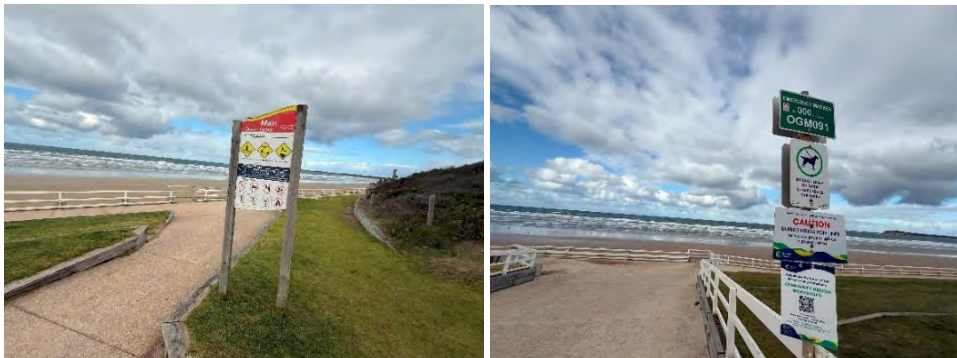
Figure 8: (a) Emergency details and beach safety signage (b) multiple signage including dog management

These signage categories are highly visible and consistent across the region. However, signage related to accessibility, inclusive amenities, and wayfinding is noticeably limited or inconsistent.

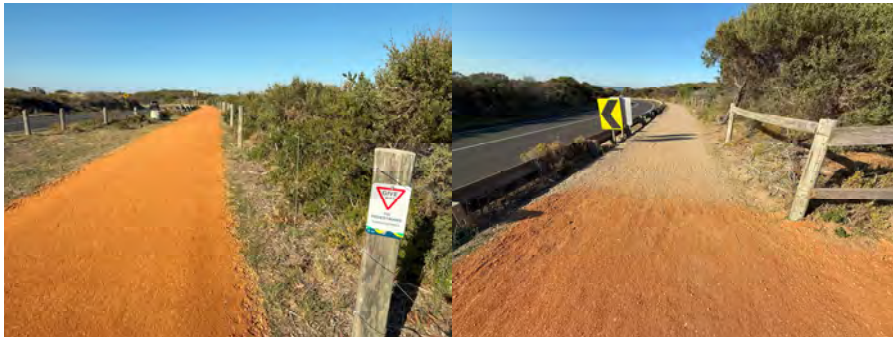
- Improved underfoot stability appears to support safer use for people with mobility devices, prams, or reduced balance, but is still not the preferred sealed
- Increased colour contrast provides a clear delineation between the path and surrounding ground surfaces, supporting wayfinding for users with low vision
- The clearer visual boundary encourages and reinforcing the defined path to be used

**Figure 14: Contrast of gravel types, 13th Beach first car park**

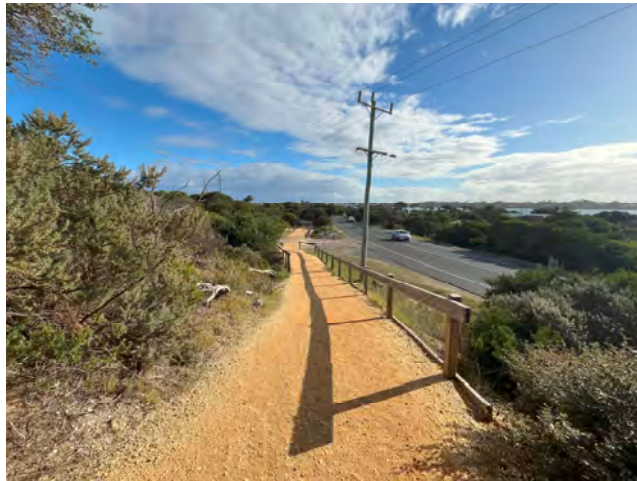
Barwon Coast has also commenced upgrades to trail gradients along key routes, significantly improving accessibility for many users. While this is a positive development, it is recognised numerous sections of the coastal trail network still contain steep gradients that cannot be fully modified to meet Continuous Accessible Path of Travel (CAPT) requirements due to environmental and topographical constraints.

**Figure 16: Modification to trail to reduce gradients**

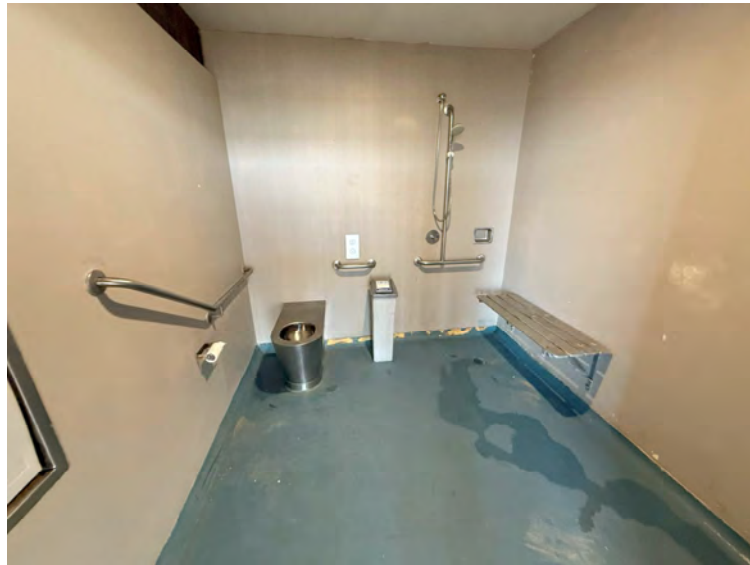
Ocean Grove Main Beach is the only site along the Barwon Coast that offers two accessible toilet and shower facilities, providing essential amenities for individuals with mobility needs and their carers, unfortunately not all elements of the design are met due to installation of “vandal proof” features, such as no contrasting toilet seat or back support being provided. This commitment to inclusive infrastructure is further underscored by the imminent opening of a Changing Places

**Figure 22: Current accessible bathroom Ocean Grove Main Beach**

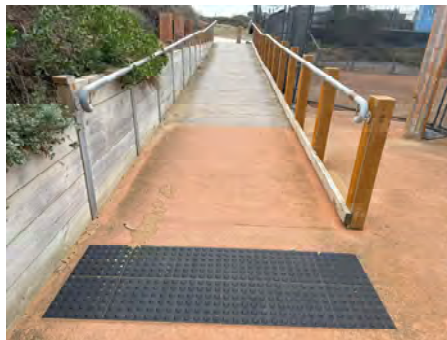
There is inconsistency across the Barwon Coast in the installation and application of TGSIs. While it is encouraging to see that more recent upgrades and infrastructure improvements are incorporating TGSIs in line with accessibility standards, earlier sites and legacy assets often lack this essential wayfinding and hazard warning feature.

Figure 23: TGSi examples: (a) Ocean Grove main beach toilet amenities

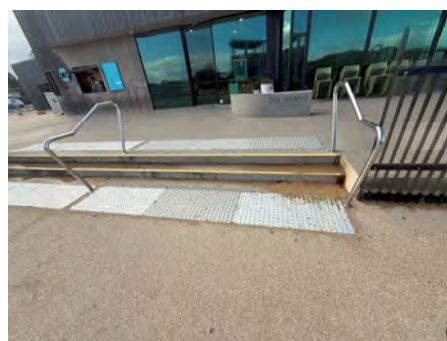
(b) Stairs to Dunes Café, Ocean Grove Main Beach

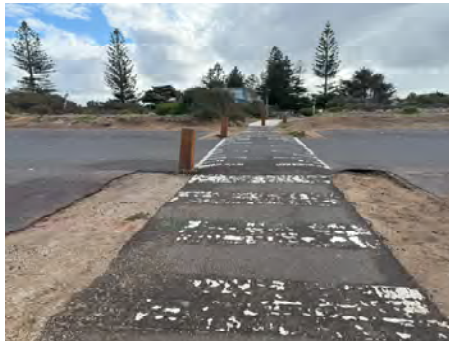
(c) Pathway across Ocean Grove Main Beach car park

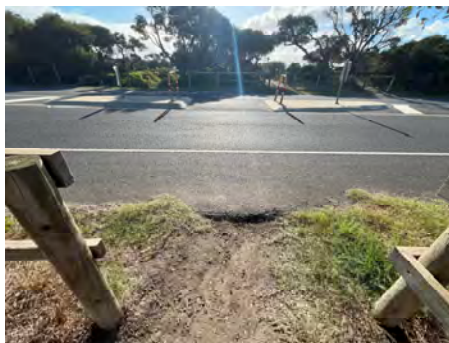
(d) path leading across the road on Ocean Grove side of bridge, ocean side leading to river side

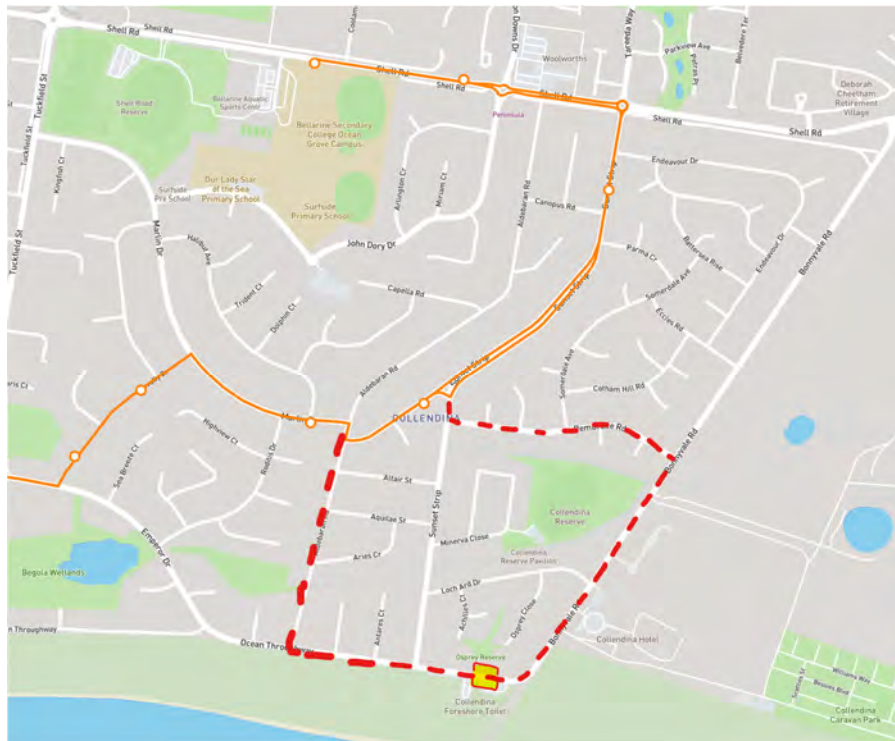
**Finding:** There is no direct public transport service to Collendina Foreshore. The closest bus stop (Route 55) is more than 600 metres away, with no accessible path of travel or directional signage linking it to the foreshore. The distance and lack of guidance limit access for people who do not drive or use mobility aids.

Figure 31: Potential new bus route and location for accessible bus stop location

**Action:** Advocate to Public Transport Victoria (PTV) for improved coastal service coverage and installation of accessible infrastructure at key drop off points. Promote existing access limitations on digital platforms to inform visitors. Consideration of seasonal shuttle bus in consultation with other agencies, COGG & DPT.

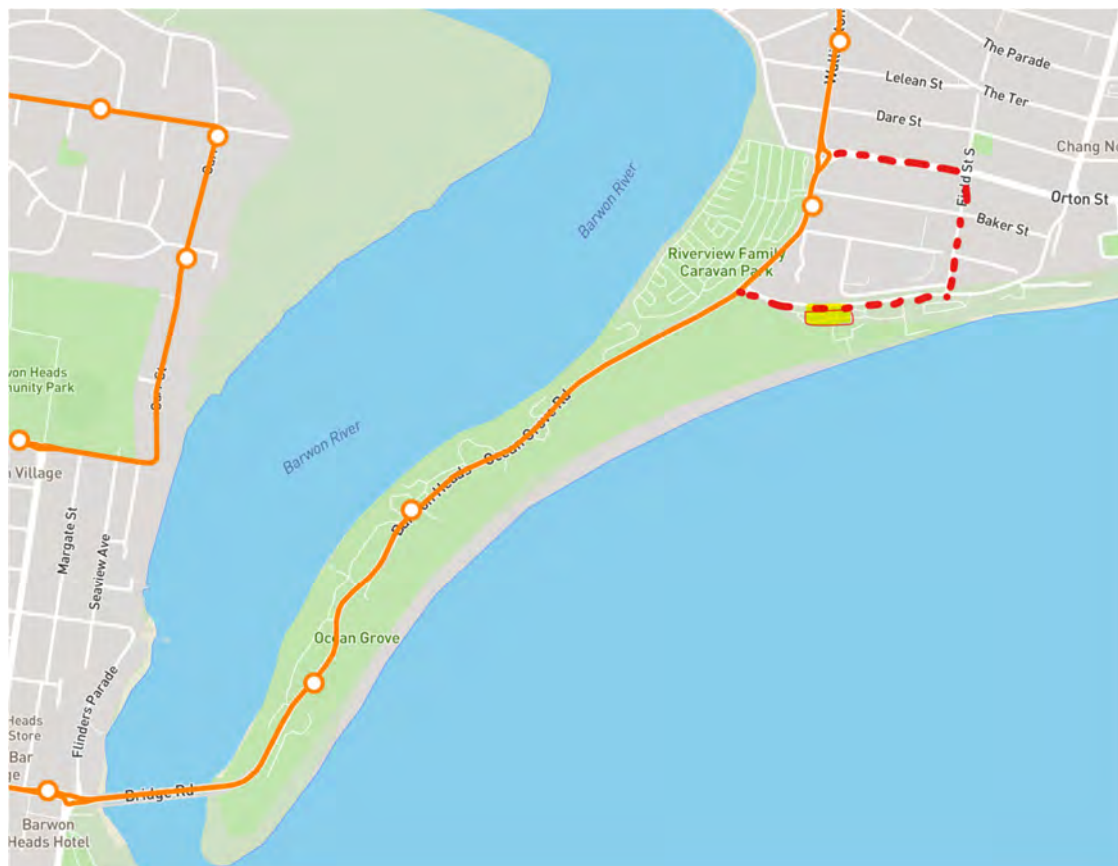
Figure 35: Potential change to bus route

- Advocate to COGG and DPT for a change in bus route to include Ocean Grove main beach and create fully accessible stops at both ends of the trail with compliant design (pads, shelters, tactile features).
- Install connecting paths from key bus stops to the trail.
- Improve wayfinding signage from existing stops.

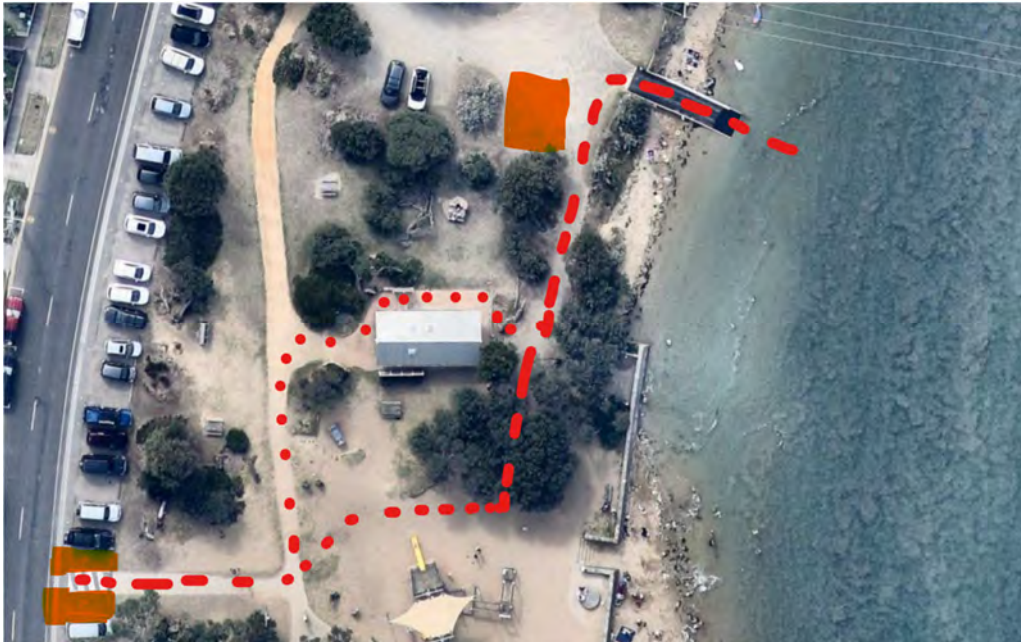
**Figure 36: Potential to formalise pathway, modify accessible change room / shower, and increase / modify ramp out into the river to create access to the water.**

- Resurface play zones and reconnect play elements with accessible paths.
- Maintain pathways and remove trip hazards.
- Promote inclusive features via signage and maps.
- Investigate installation of new accessible play equipment

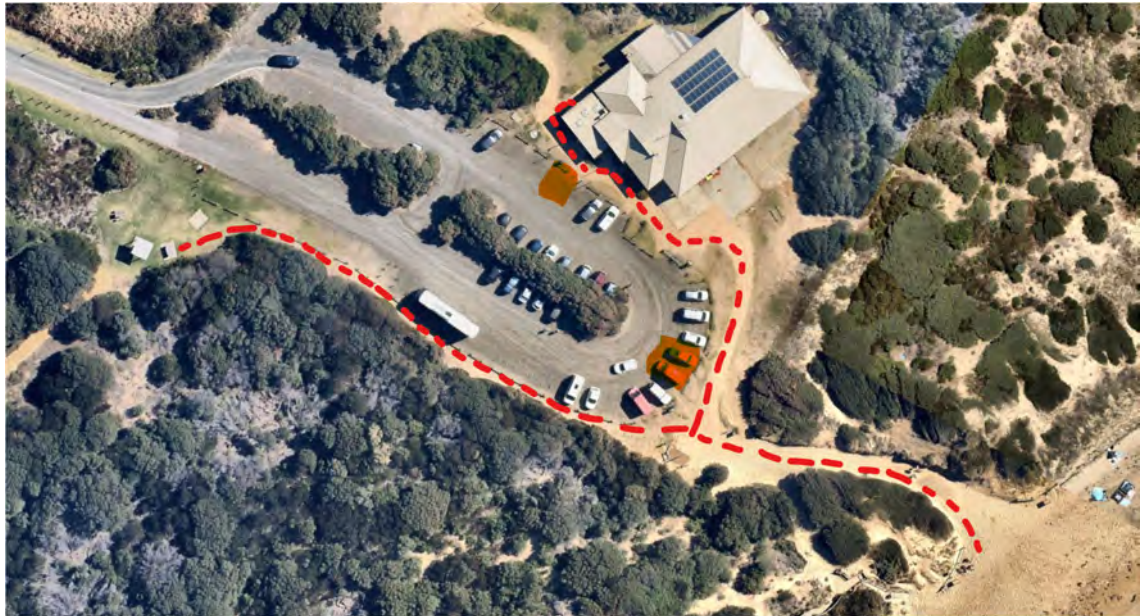
- CAPT links surf club, amenities, and beach entrance but:
  - o Becomes unstable and sandy near the beach.
  - o Has a steep 1:6 gradient in one area.
  - o Vehicle use near surf club has caused surface damage.
- Western gravel trail to picnic area is not compliant (uneven, narrow, crossfall).

Figure 37: Potential CAPT and locations for accessible car parking bays

- Barwon Coast to decide on most appropriate path to connect the region.
- Create a CAPT to withstand sand accumulation and provide slip resistant stability.
- Regrade steep areas or install compliant ramps.
- Upgrade trail to picnic area with sealed path and better definition.
- Consider impact of moving sand, and the most appropriate location for CAPT at this site.

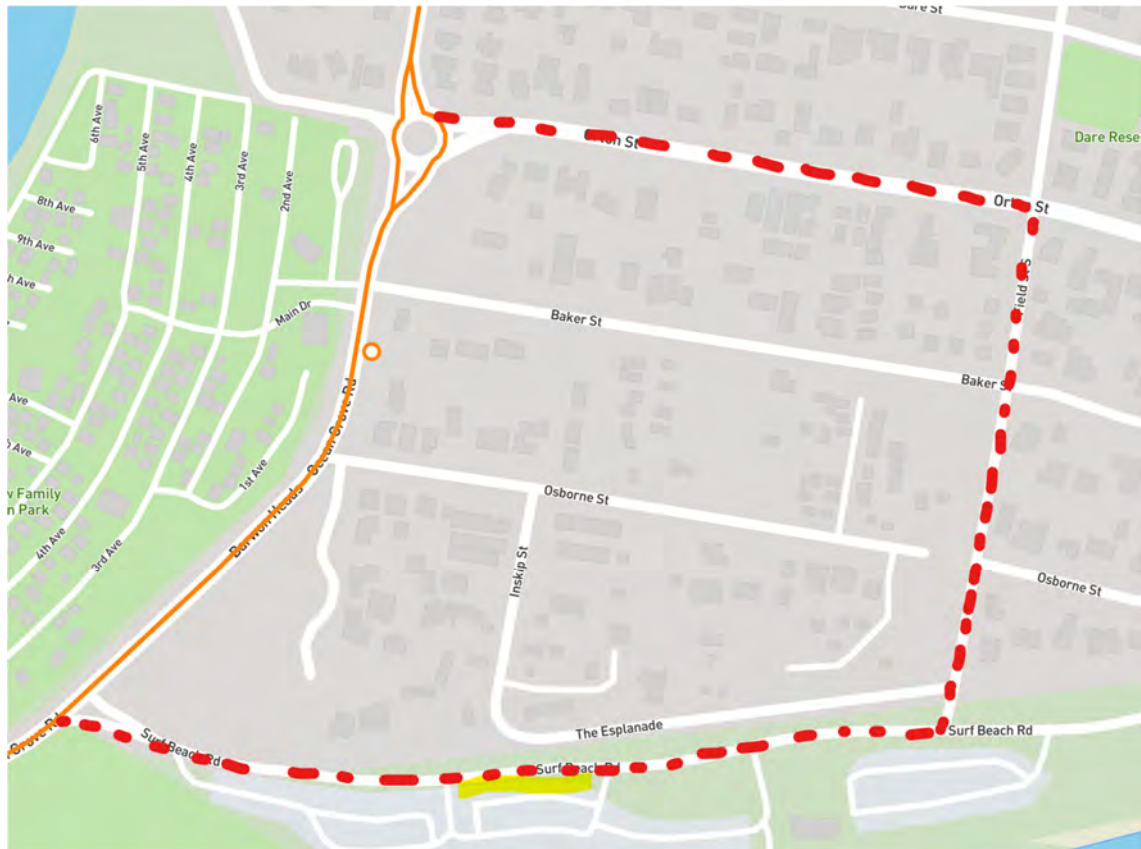
Figure 38: Potential changes to public transport route and drop off / pick up location.

- Advocate for improved drop off locations with accessible features and direct connection to CAPT.
- Install directional signage from the bus stop to beach entrances.
- Update websites to clearly explain public transport limitations.
- Investigate sessional shuttle bus service.
